# Copy of Fuel and Air Saver Customer's NAPA Oil Analysis Report

**NAPA**  
**Filters**  
 Oil Analysis Report

**MAKE:** TOYOTA  
**MODEL:** TACOMA  
**OIL BRAND:** CASTROL  
**OIL TYPE:** 5W30  
**SERIAL NO.:**  
**FUEL TYPE:** GASOLINE

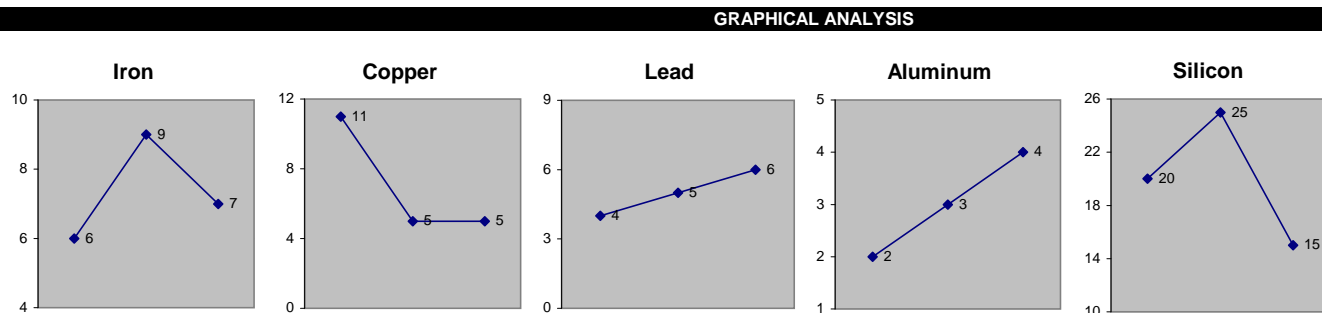
Miles: 73900, 62550, 50200

LAB#	ANALYSIS RECOMMENDATIONS	ANALYST
16707	TRACE LEVEL OF WATER DETECTED. NOTE: TEST RESULTS INDICATE THIS OIL IS IN THE SAE 30 RANGE. NO FUEL DILUTION DETECTED THIS SAMPLE. EXCESSIVE WEAR IS NOT INDICATED. NO RECOMMENDED ACTION AT THIS TIME RESAMPLE AT NORMAL INTERVALS	ANALYST-MHC
150976	RESULTS OF TEST PERFORMED INDICATE NO CORRECTIVE ACTION REQUIRED	ANALYST-GGD
134870	RESULTS OF TEST PERFORMED INDICATE NO CORRECTIVE ACTION REQUIRED	ANALYST-A.A
